GEOSTRAHA

OCTOBER // NOVEMBER 2022

DEVELOPING THE UNDEVELOPABLE

Geotechnical Solutions for
Complex Hillside Construction

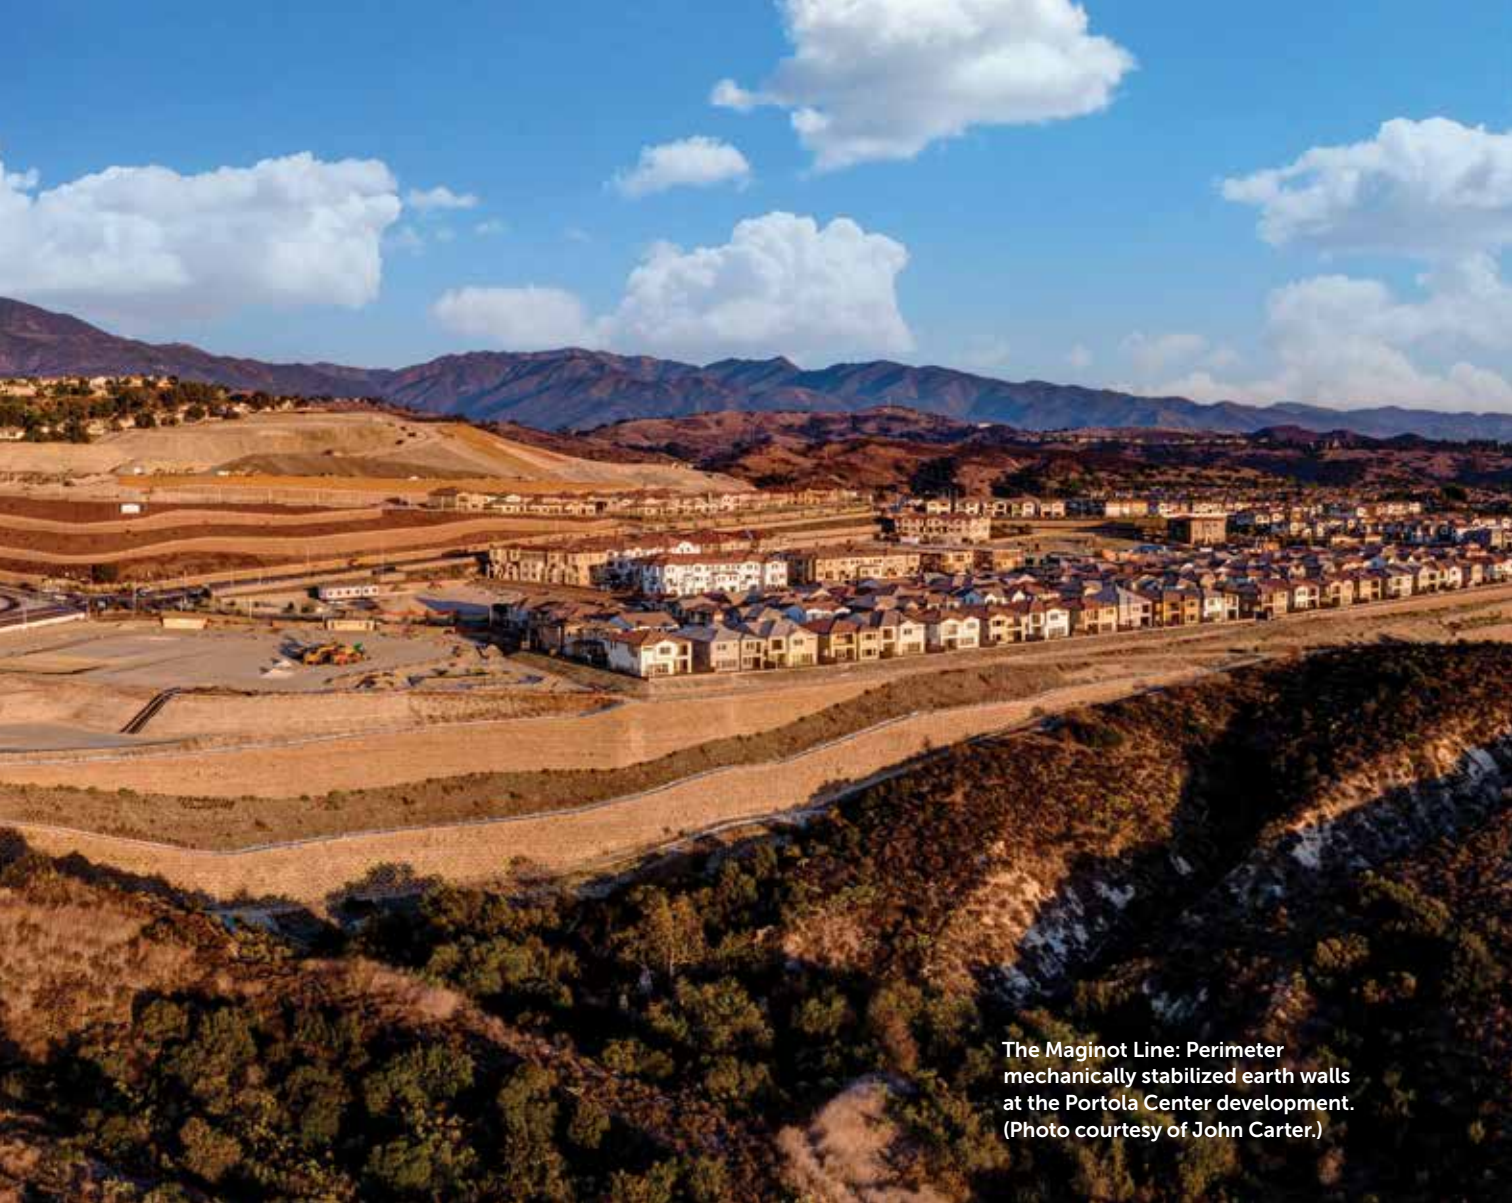
The Maginot Line: Perimeter mechanically stabilized earth walls at the Portola Center development. (Photo courtesy of John Carter.)

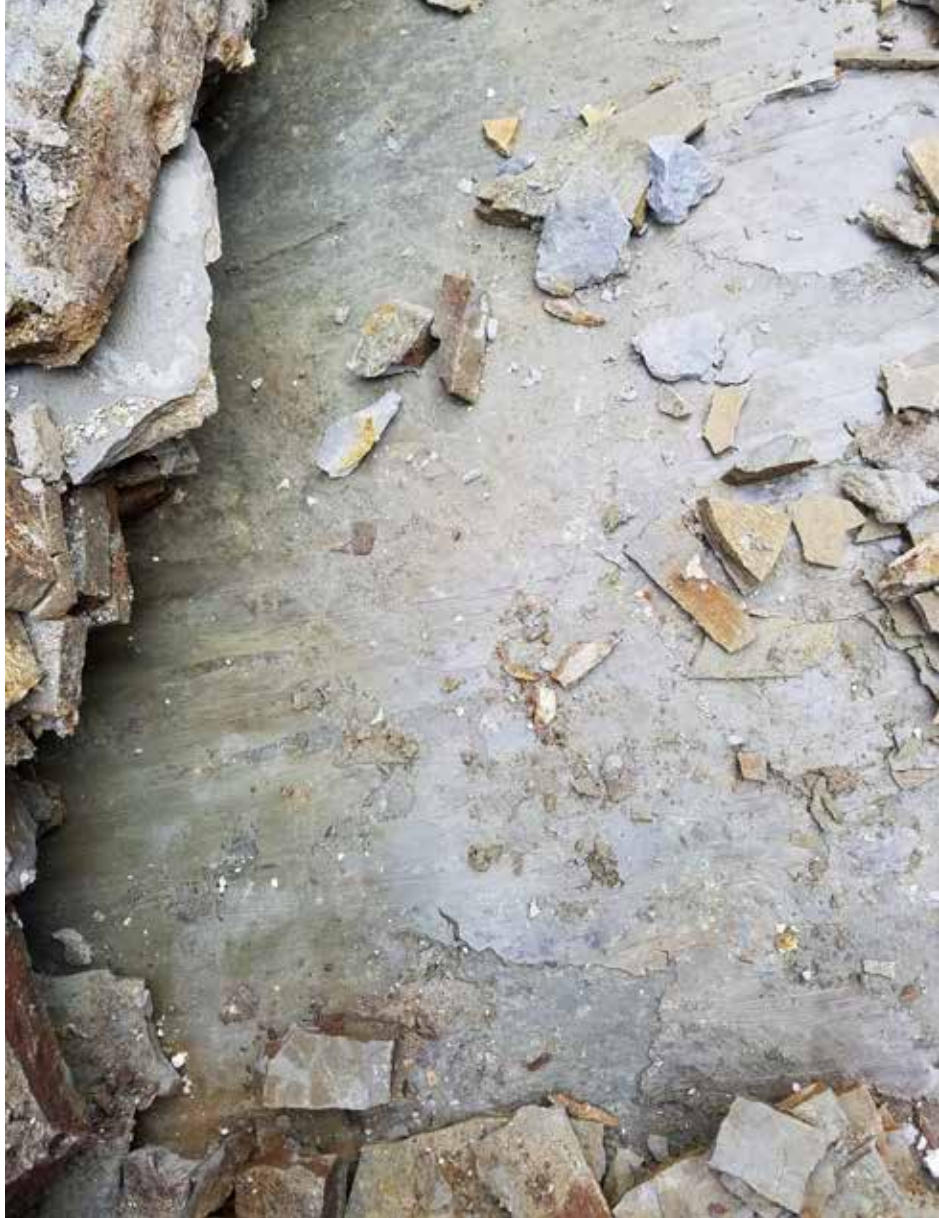
Figure 1. Slickensided remolded clay on a hard siltstone bed at the base of a backcut failure headscarp during buttress excavation.

of BPSs affecting project design. BPSs are comparable to sliced Swiss cheese: continuous, but not necessarily present at all boring locations penetrating the same stratigraphy. In the end, 12-14 near-continuous BPSs were identified, ranging in thickness from paper thin to about 2-in. (Figure 1).

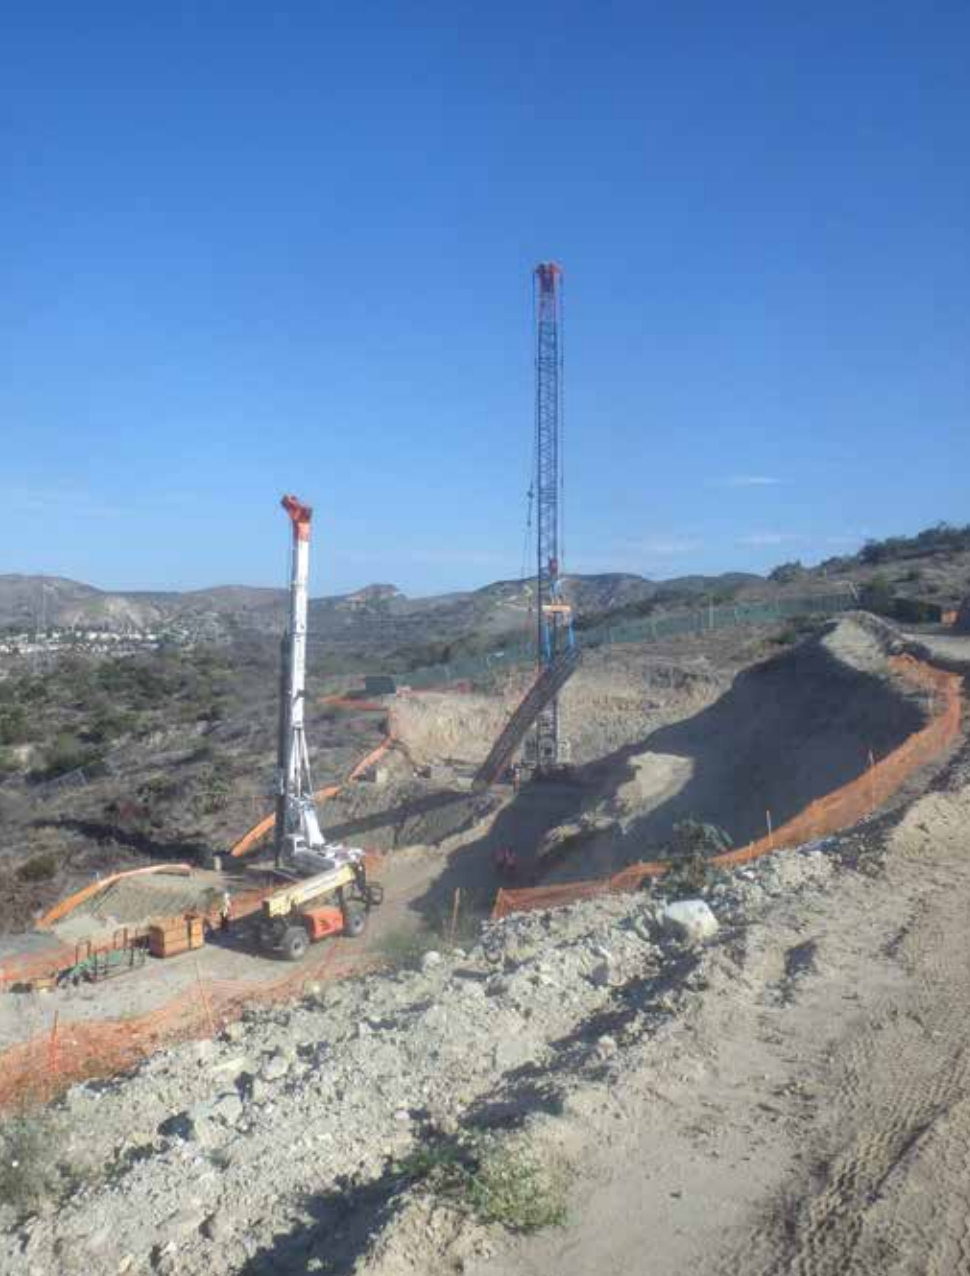
Figure 2. Shear pin construction along the northern boundary of Portola Northwest, adjacent to Whiting Ranch Wilderness Park.

1,200 ft, to interrupt five different BPSs. Where limited by property boundary conditions, existing off-site improvements, or because excavation to exposure depths was impractical, shear pins were evaluated to determine the design resistance needed to increase the FOS to an acceptable level (Figure 2). Grid lengths for the proposed MSE walls were increased where necessary to increase the FOS for potential failures through or behind the reinforced zone.

1.25 million cu yds, and one single- and one double-row of vertical shear pins constructed in 60-in.-diameter drilled shafts extending up to 65 ft in length (Figure 2).

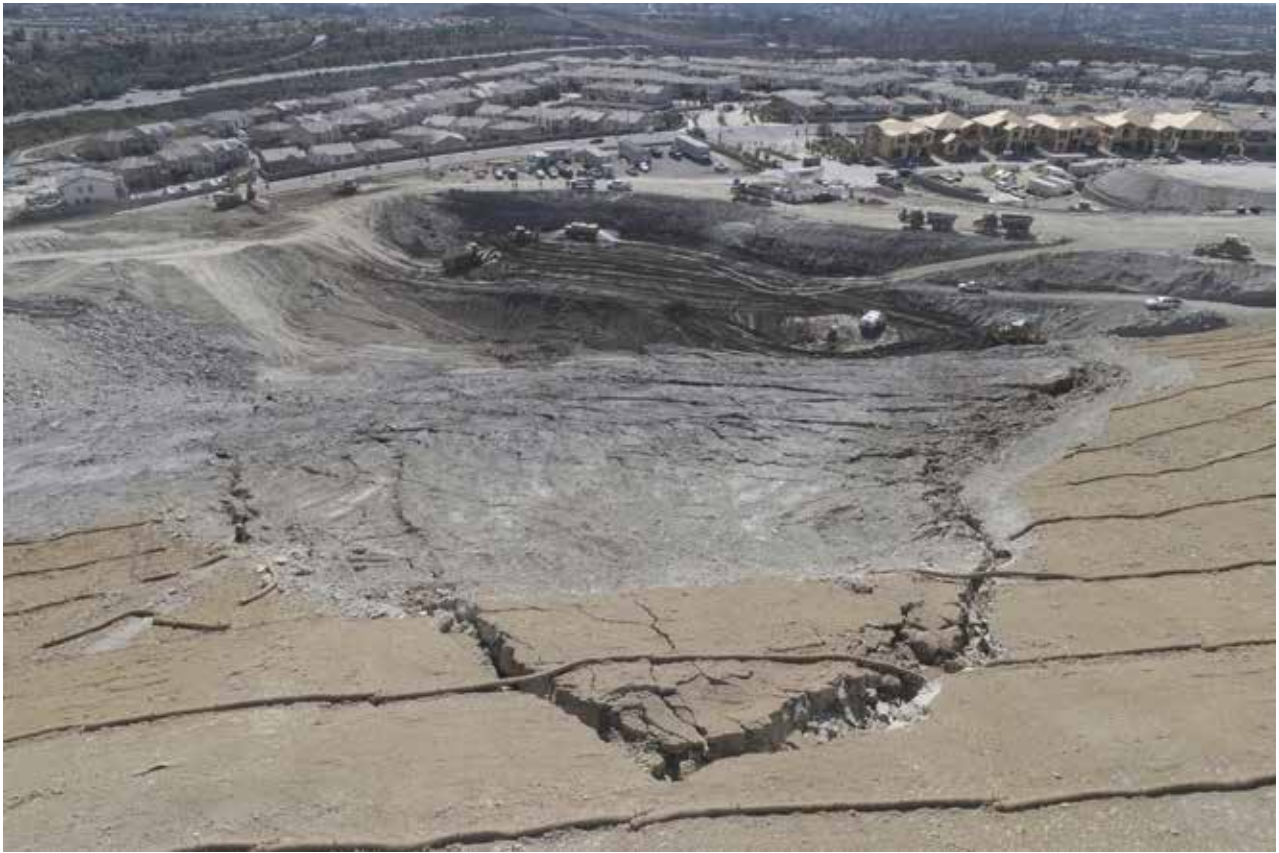
Figure 3. A typical day of buttress grading... another backcut failure along a remolded clay seam during buttress grading on Portola Northeast. (Photo courtesy of John Carter.)

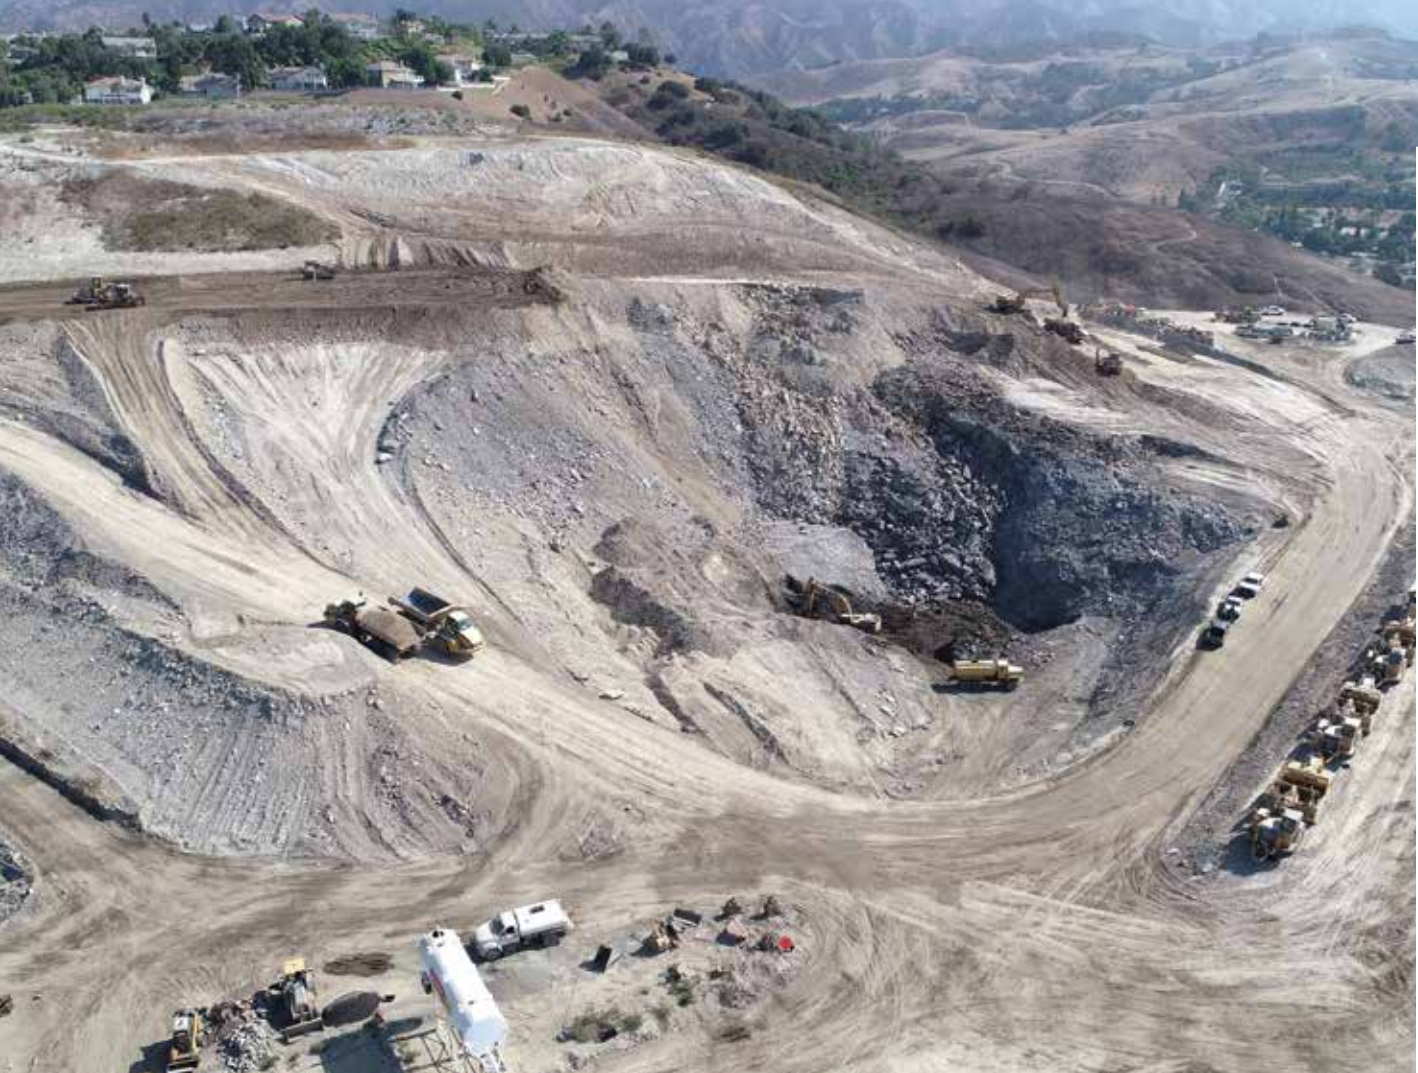
Figure 4. Slot-cutting to reach keyway elevations. Benching and placement of fill in the recently completed slot behind the water truck (foreground). Collapse of excavation sidewall along a remolded clay seam daylighted in the next keyway slot (background). (Photo courtesy of John Carter.)

The challenge of backcutting the landscape for construction of stability buttress and shear pins was a "downhill" struggle. In some cases, as many as five BPSs were exposed in cut slopes before the target buttress depth was reached. Cuts 2H:1V or steeper were typically unstable, and planar failures along remolded-clay seams occurred almost daily (Figure 3). Flatter 3H:1V backcuts approximating dip slopes were attempted to improve excavation stability and safety, but even those occasionally failed. Buttress slot-cutting techniques were used to limit the size of potential backcut failures above the deepest keyway excavations (Figure 4). In the end, preventing backcut failures proved futile,

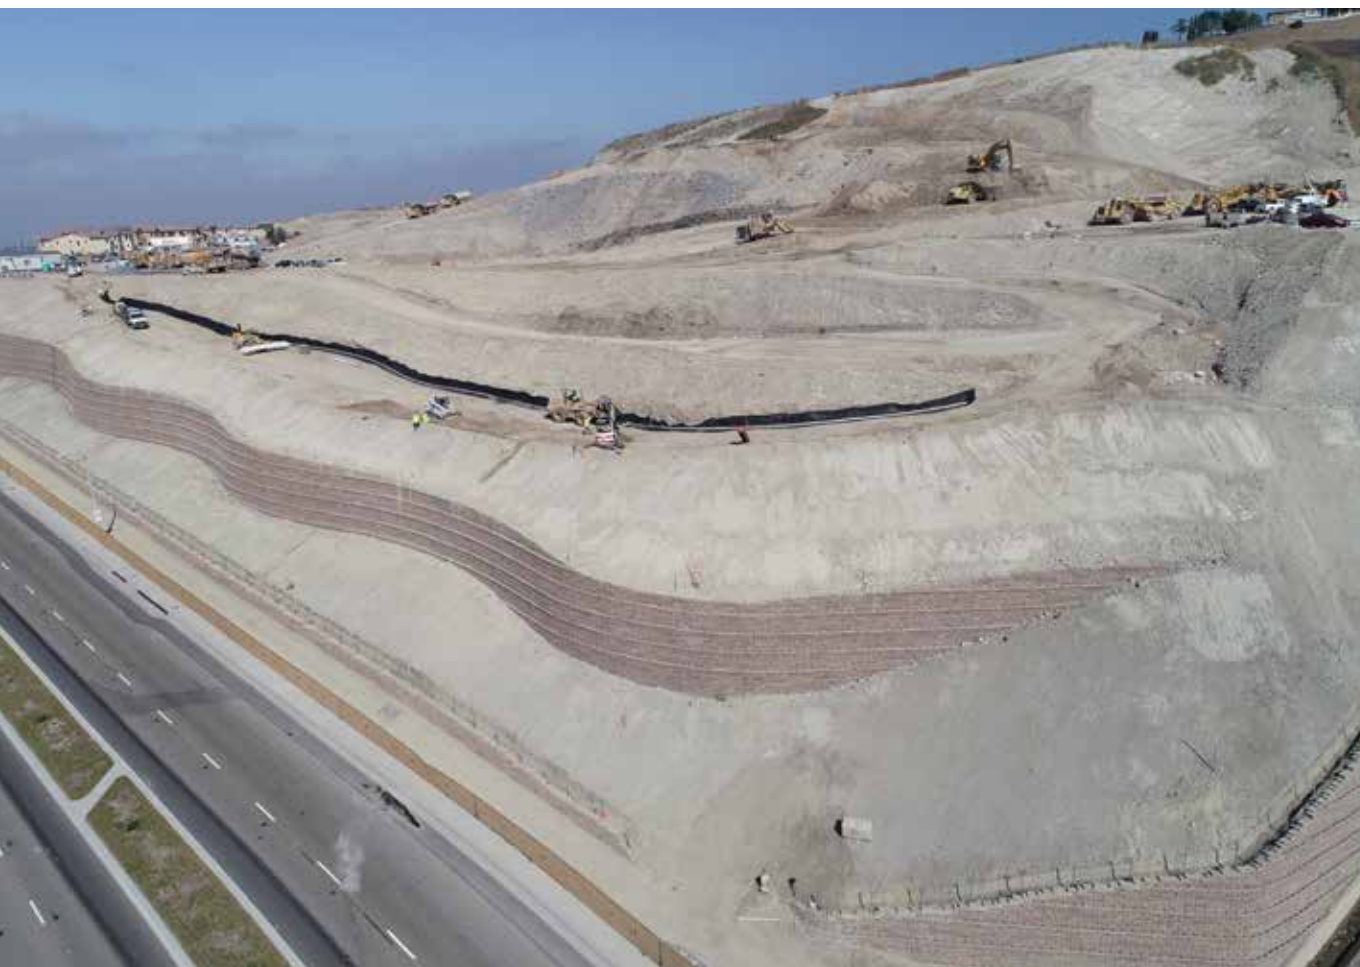
Figure 5. Construction of a three-tiered MSE wall/slope combination (foreground) and ongoing buttress excavation (background). (Photo courtesy of John Carter.)

approximately 30 ft, totaling almost half a million sq ft stretched over 36,000 lineal ft (Figure 5). The longest single MSE wall was approximately 2,200 lineal ft. Multiple uniaxial geogrid strengths were used in the design, ranging from Mirafi 3 XT up to 24 XT.

Constructed almost exclusively using nonlinear, freeform layouts with sloping backfill in single, double, triple, and quadruple wall/slope configurations, MSE walls and 2H:1V fill slopes spanned elevation breaks up to 100 ft in some areas (Figure 5). Aesthetically, perimeter MSE walls were often constructed with repeating plantable block courses to soften exterior project exposures with landscaping. The success of plantable MSE walls was mixed, owing to the amount of irrigation necessary to keep the plants alive during hot, dry California summers. Near vertical, nonplantable walls were often chosen
